Bridge Status #2

Construction of Bridge

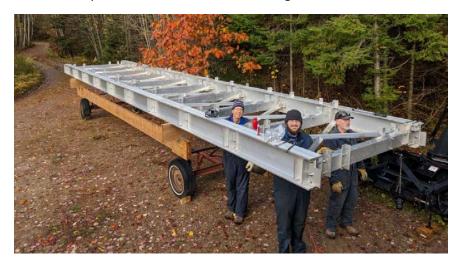
The previous status report showed the bridge frame without the stringers or wooden deck, as shown in the photo below. Tim Sykes led the construction at his place on Ross Meadowcroft's wagon.

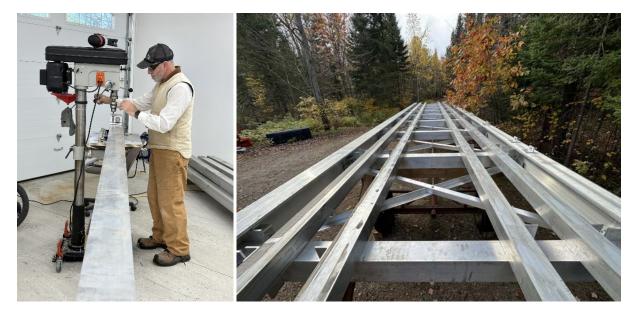
Four stringers, made of 4-inch square aluminum tubing running the full length of the bridge, were drilled to match the holes in the brackets and then bolted to the framework. These stringers reduce the span of the wooden planks (which run across the bridge) so that they will be capable of supporting concentrated loads from maintenance vehicles (e.g., a tractor).

All fasteners were stainless steel, mostly ½" and 5/8" diameter. Loosening of nuts was prevented using either locknuts with nylon inserts plus Loctite, or double nuts plus Loctite, torqued to the appropriate level.

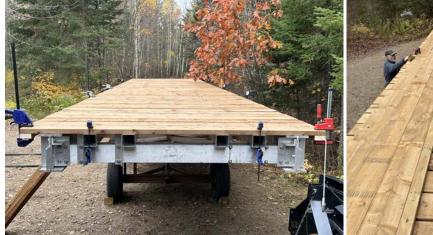
The wooden deck was then installed. Shown in the photo below on the left is the first layer, consisting of 8-foot long planks running across the bridge, followed by longitudinal runners to spread wheel loads to multiple planks and increase overall rigidity (shown in the photo on the right). Layers of wood were attached together using large-head self-drilling outdoor screws (5/16" GRK RSS). The deck and the stringers were both designed to slide slightly on the substructure

when the bridge is heavily loaded. Curbs, shown in the installation photos later in this report, were then added to the edges of the deck.
